## Comparison of Corrosion Rate on Paint Coated and Uncoated SS400 Steel

### Abstract

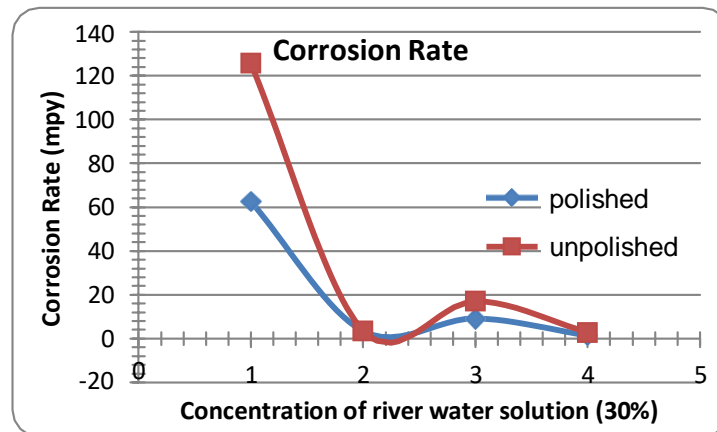
Figure 3.3 Corrosion Rate for Unpolished and Polished Specimens dipped in River Water Solution

Corrosion rate for river water solution gave the similar results. The corrosion rate for uncoated specimen was the highest both for unpolished and polished one. Different paint also gave different result on corrosion rate after dipped into 30% concentration of river water solution for 15 days as shown in Figure 3.3.

Note: 1. Uncoated specimen 2. Paint coated Jotun 3. Paint coated Avian 4. Paint coated Pylox

Pylox coated specimen was most resilient againsts corrosion for 1.33 mpy for polished one and 2.75 mpy for unpolished one. The uncoated specimen was prone to corrosion process for 125.68 mpy. The results were in accordance with previous research [8].

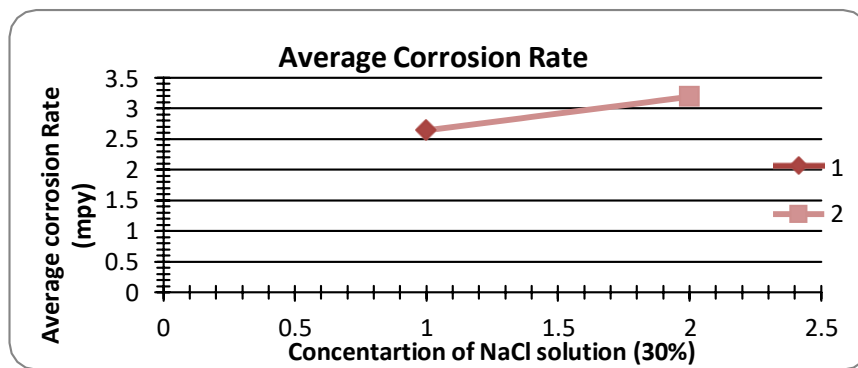
Figure 3.5 Average Corrosion Rate for 30% Concentration of H<sub>2</sub>SO<sub>4</sub> Solution

Specimen dipped into HCl solution also show similar trend with the polished specimen has lower average corrosion rate compare with unpolished one. The unpolished one has average corrosion rate of 3.19 mpy while the polished one has average corrosion rate for 2.64 mpy as shown in Figure 3.5.

- Note: 1. Polished specimen 2. Unpolished specimen
