**AN INNOVATIVE AND COST-EFFECTIVE APPROACH TO MASONRY  
CONSTRUCTION RENOVATION**

**Naved Husain<sup>1</sup>, Dr. Sanjeev Singh<sup>2</sup>**, Department of Civil Engineering, Shri Venkateshwara  
University, Uttar Pradesh (India)

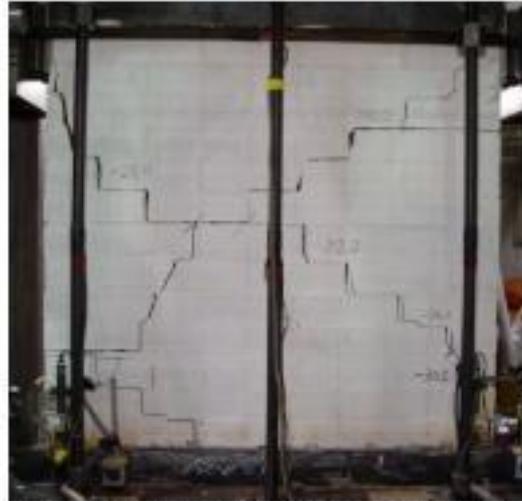
**Photo 2.** Unreinforced wall crack pattern

Pictures 2 and 3 depict crack patterns. Figures 2 and 3 show force-deformation curves grouped by pre-compression load from several experiments. The following section summarises the experiment's findings.

Reinforcing does not change the pattern of cracks as shown in photographs 2 and 3. Early in both loading processes, flexural forces caused a crack in the lowest layer of mortar. This crack grew wider and longer as the horizontal load increased. Because the crack in the reinforced walls proceeded slowly, the force-deformation curve did not reveal a drop in wall strength. This impact may be seen on 9kN VL walls. When the shear-flexural mechanism delivered horizontal force to the support, the flexural crack permitted a compression strut to withstand it. The specimen stresses had been building up due to the bottom crack's failure to propagate when a diagonal crack appeared. After the first diagonal crack developed, the failed wall's strength was notoriously reduced, and the imposed deformation that followed was linked to the movement of the failing wall's upper half. As soon as the load was reversed, the flexural cracking stopped completely. The biggest shift occurred along the top of the wall. After the initial shear crack closed, the stresses re-accumulated, resulting in the emergence of a second diagonal crack on the opposite diagonal. Between the unreinforced and

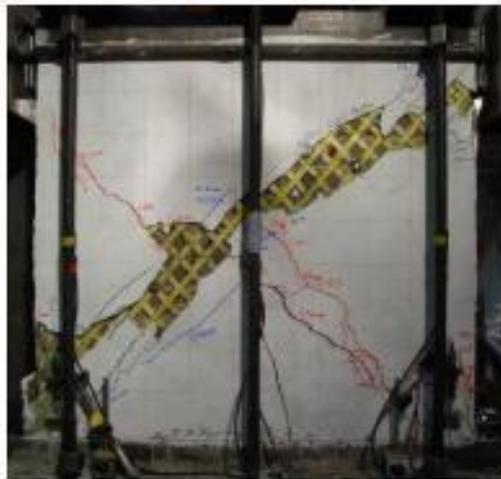
**Photo 3. Reinforced wall crack pattern**
